7th International Symposium on Cement Based Materials for a Sustainable Agriculture

SKID RESISTANCE AND DURABILITY OF COATED AND UNCOATED CONCRETE FLOORS IN DAIRY CATTLE BUILDINGS

CSAS11037 – Section 4: Concrete Floors for Animal Housing.

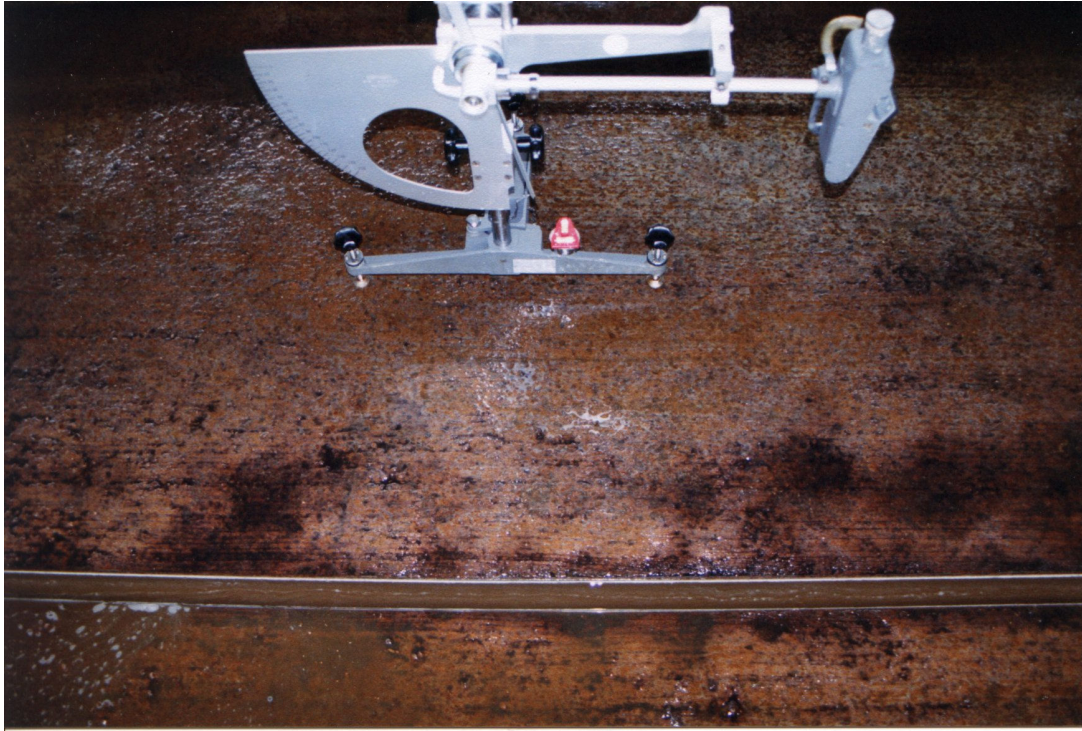
Figure 3: Pendulum tester to measure skid resistance (SRT) on a wet concrete floor of a cattle building.

MATERIAL AND METHODS SRT Measures were performed in six different cattle buildings providing floors of uncoated concrete, brushed concrete, epoxy resin coating and mastic asphalt. The cattle buildings were located in the federal state of Thuringia in Germany. Measures were done using a Skid Resistance Tester (Figure 1). The SRT value is a kind of dynamic friction measuring method. The pendulum (Figure 1 and Figure 2) is accelerated up to 2.5 ms^{-1} , a slider with a rubber block at the pendulum scratches on the watered floor for an equal distance. Depending on the floor roughness, the pendulum is de-accelerated and moves a pointer at a scale, the so called SRT - Value. A value of zero is obtained without any friction or free swinging of the pendulum arm. The surface has to be watered and cleaned before the measure. Figure 3 shows the SRT Tester in its working environment on a passageway of a cattle building.

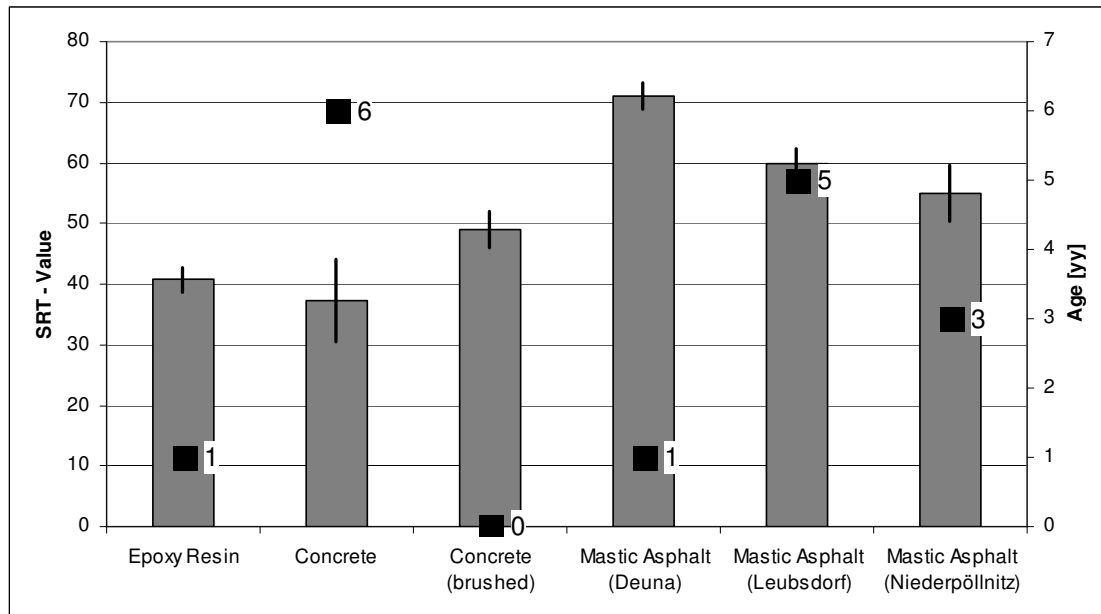
The results from our Skid Resistance Tester are shown in Figure 4. Six years old concrete and concrete with epoxy resin coating (1 year old) with $SRT \leq 40$ showed poor grip values. The floors were suitable as walking surfaces in cattle buildings. A recently installed brushed concrete had acceptable grip at SRT of 49, whereas mastic asphalt coating resulted in excellent good and sufficient grip. Mastic asphalt has even if it is 5 years old good grip properties.

Figure 4. SRT-values for 6 different floor types (grey column) and age in years (black square).

DISCUSSION Results of SRT-values indicate that uncoated concrete should either be coated with mastic asphalt in order to get durable grip or – if left uncoated – finished by using a brush. Considering results of Franck et al. (2007) mastic asphalt can maintain grip for a long time. The reason can be a changed micro-roughness, even mastic asphalt gets eroded by cleaning device and faeces. As a result, “peaks” of rigid components remain within the surface and thus lead to constantly high SRT-values. Concrete will remain or erode to a slippery surface within the same time. Our results seem to be in line with those of Van der Tol et al. (2005), who stated, that the dynamic coefficient of friction of concrete, which is highly correlated with SRT-values, is not suitable for an unrestrained cattle locomotion. Epoxy resin as coating remained even after sandblasting relatively slippery and had lower SRT-values compared to grinded concrete surface.

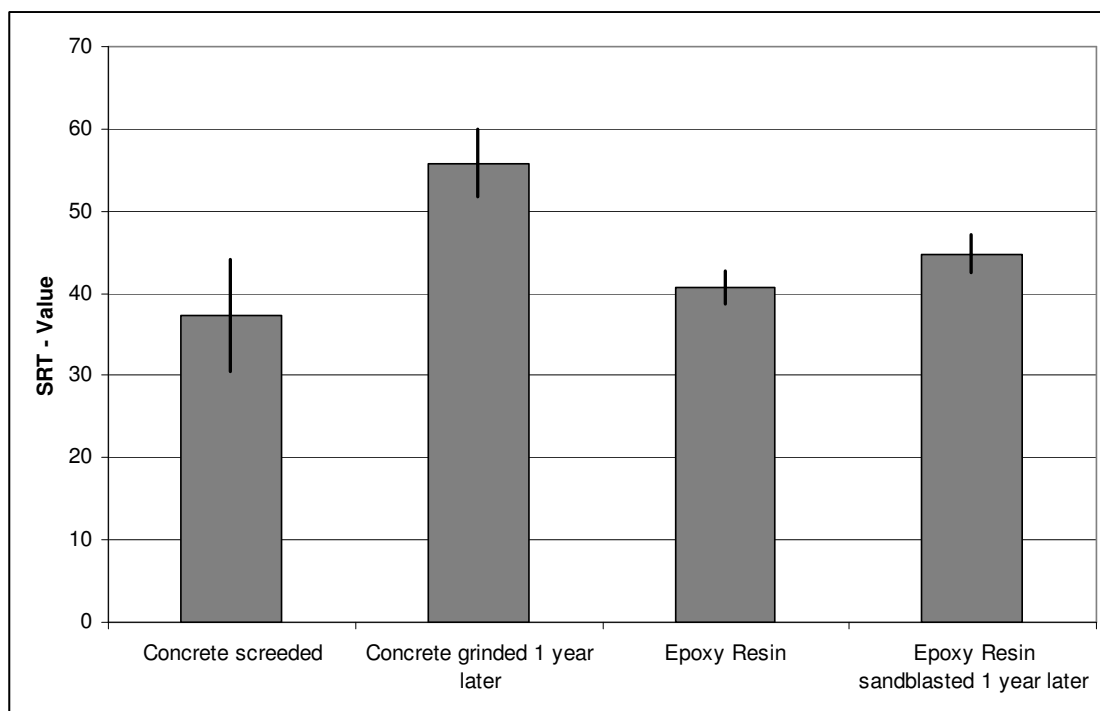
In order to show how farmers could improve a poor grip of concrete floors, we measured concrete floors and epoxy coated floors before and after renovation. The results are shown in Figure 5. Grinding of poor screeded concrete resulted in good grip of SRT = 55. An epoxy resin coated floor with slippery properties was sandblasted to improve grip. The sandblasted epoxy floor had increased SRT-values of 44 which maybe sufficient.

Figure 5: Concrete and epoxy resin coated concrete before and after processing.
